Monitoring Data Record

Project Title: U-2524AC Site 1 COE Action ID: 200321137

Stream Name: UT No. 9 to Bull Run DWQ Number: 030909

Year 1 Summer – July 2006

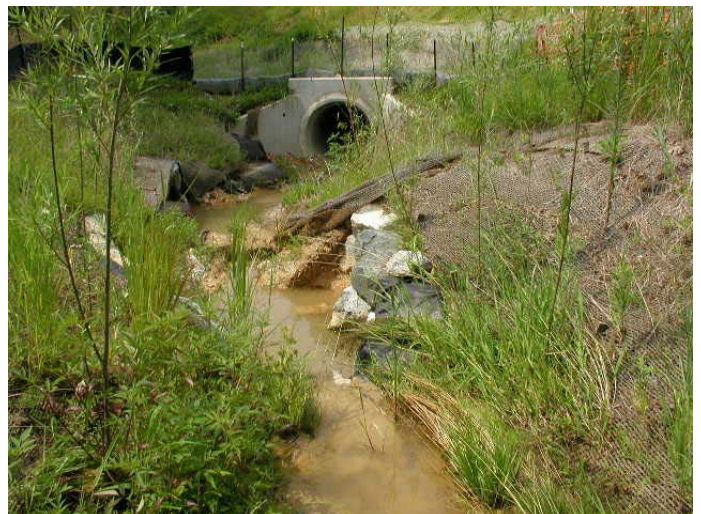
Photo Point #3 (Downstream)

The channel is stable throughout the entire onsite stream relocation project, except for some minor bank erosion below a crossvane (Photo Point #3 Downstream).

Date Inspected	Sta. 58+20-L-	Station Number	Station Number	Station Number	Station Number
Structure Type					
Is water piping through or around structure?					
Head cut or down cut present?					
Bank or scour erosion present?	Minor Bank Erosion
